Tembungo Salm — Seven Years Operating Experience

by R.D. Swan, S. Van Zeller, Esso Production Malaysia, Inc., and R.H. Gruy, Sofec Inc, USA

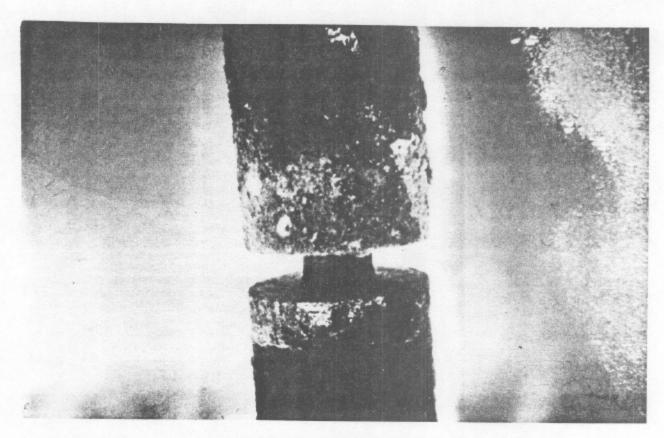
Figure 9 - Photo-Chain Swivel

On May 11 during a routine inspection dive, divers noticed that the gap between the two moving parts of the chain swivel had opened up quite considerably. The gap was measured to be 2½", as compared to the original as-built gap of ½". At this time the decision was made to install a spare chain swivel located at the warehouse in Kota Kinabalu. (Later detailed investigation by the manufacturer revealed that swivel failure was due to failure of the oil seal between the shank and the barrel. Loss of lubricant and subsequent deterioration of the bearing in seawater caused bearing failure and total lock-up of the swivel. Since then a new seal arrangement has been designed, consisting of a TURCITE element energized by a BUNA-N insert, plus a guide spacer to prevent 'cocking' of the shaft during shipping and handling).

As the only support vessel available at the time was a 130-foot supply boat with a four-point mooring system, it was necessary to wait for calm weather. By May 27 the gap was 41/4" (Fig. 9). During this period, detailed preparatory work was carried out, including fabrication and installation of a support frame for the upper universal joint (Fig. 10), and a support cradle for the main shackle pin.

The vessel was anchored and ballasting of the buoy commenced on June 1st. After the chain assembly was slack (Fig. 11), a 15-ton hydraulic jack was used to remove the pin from the shackle connecting the chain assembly and universal joint (Fig. 12). The buoy was then de-ballasted, the anchor chain assembly winched over the stern roller and onto the deck of the supply boat, and the buoy secured to the stern of the vessel. The chain swivel and connecting shackles (Fig. 13) were replaced and lowered into the water, and the buoy re-ballasted. The four-point mooring system was then manipulated to precisely position the shackle over the universal joint, and the pin installed using the hydraulic jack and pre-installed pin cradle (Fig. 14). Total downtime amounted to only 69 hours from shutdown of production to restart of production through the SALM, thus illustrating the value of thorough preparation (total preparatory dive time was 9.5 hours vs. 8.9 hours diving during the actual replacement operation).
