# FIVE YEARS EXPERIENCE WITH THE FIRST DEEPWATER SALM

by Robert H. Gruy, William L. Kiely, Kris I. Pederson;  
Sofec, W.R. Wolfram; Exxon Production Research Co. and  
Richard D. Swan; Esso Production Malaysia Inc.

This paper describes the performance of the Tembungo Single Anchor Leg Mooring (SALM) tanker loading terminal during its first five years of operation. This facility, located in 300 ft (91 m) of water, 50 miles (93 km) off-shore Sabah, East Malaysia, was the first SALM designed and constructed under commercial license agreement from Exxon Research and Engineering. The Tembungo SALM is one of the first "early production systems" and has been in continuous service since October 1974. It was designed to permanently moor a 94,000 DWT storage tanker in maximum wave heights of 39 ft (12 m), winds of 65 mph (29 m/s) and 2 kt (1 m/s) currents.<sup>1</sup>

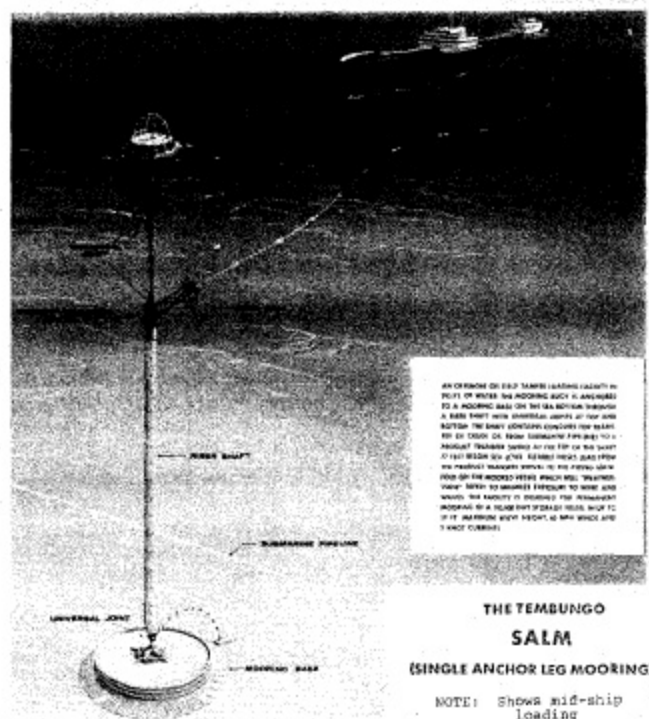
Fig. 1 - Salm perspective illustration including tanker, shows mid-shop only.

The SALM mooring buoy is anchored through a single pretensioned anchor leg to a gravity type mooring base at the seafloor (Fig. 1). The system is designed to remain constantly in tension during all operational and maximum storm conditions. The entire system was designed to be installed in three operations; set and ballast the base, attach the riser, attach the buoy. This procedure allowed the use of a small and inexpensive offshore construction spread. To minimize diver time and underwater work, the universal joint attachments between riser and base (Fig. 5) and buoy and riser (Fig. 6) were designed to be hydraulically latched (or unlatched) from the surface.

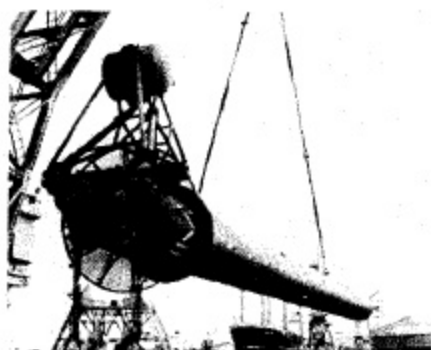
Fig. 3 - Photo - riser shaft.

Item	Description
Mooring Buoy (Fig. 2)	22 ft (6.7 m) dia. x 36 ft (11 m) high. Internally divided into 8 water-tight chambers
Riser Shaft (Fig. 3)	8.5 ft (2.6 m) dia. x 185 ft (56 m) long
Mooring Base (Fig. 4)	Gravity-type, self-floating design. In place weight 4600 kip (20,400 kN)
Anchor Leg Assembly (Fig. 6)	6 in. (152 mm) Gr. ORQ stud-link chain including permanently lubricated underwater ball bearing swivel and universal joint
Loading Hose System	10 in. (254 mm) hose string made up of four specially reinforced submarine hoses (from hose arm to surface #1, 2, 3 and 4), two surface floating hoses (#5 and 6) and one tanker rail hose. All hoses are 35 ft (11 m) long
Mooring Hawsers	Two 15 in. (370 mm) circumference nylon hawsers x 150 ft (46 m) long with 3 in. (76 mm) dia. chafing chain at buoy and tanker ends
Pipeline End Manifold (PLEM)	Gravity-type connected to SALM riser via two 10 in. (254 mm) i.d. x 35 ft (11 m) long hoses in series
